PHENIX WEEKLY PLANNING

Sep. 5, 2013
Don Lynch

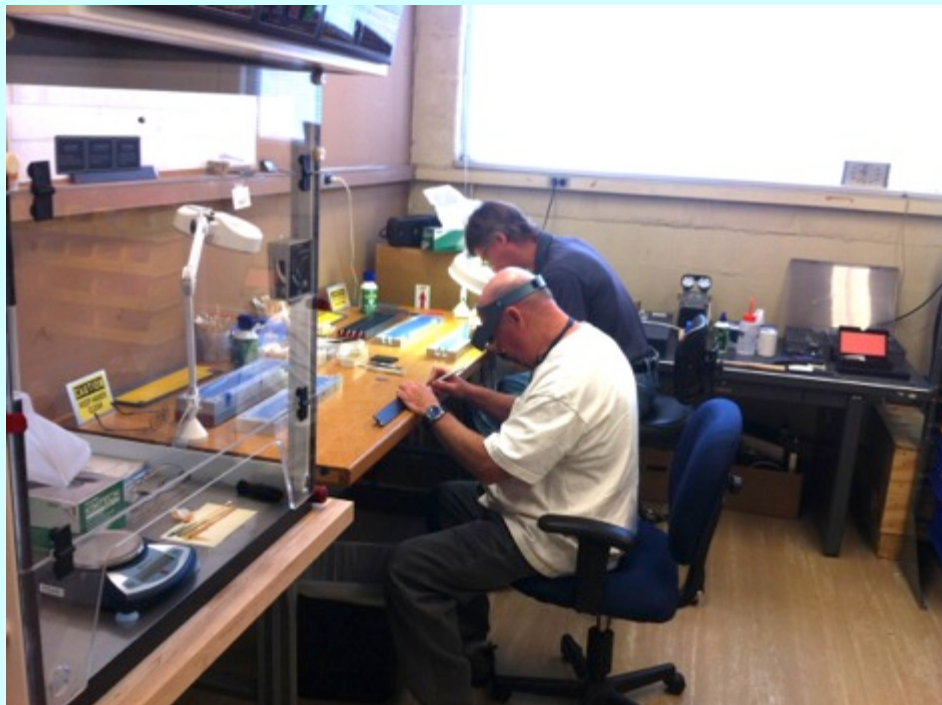
VTX/FVTX repairs/upgrades

All stripixel stave cores to be received by end of this week

Building staves to continue to ~ 9/15

Remaining pixel ladders to be received from Japan by 9/15

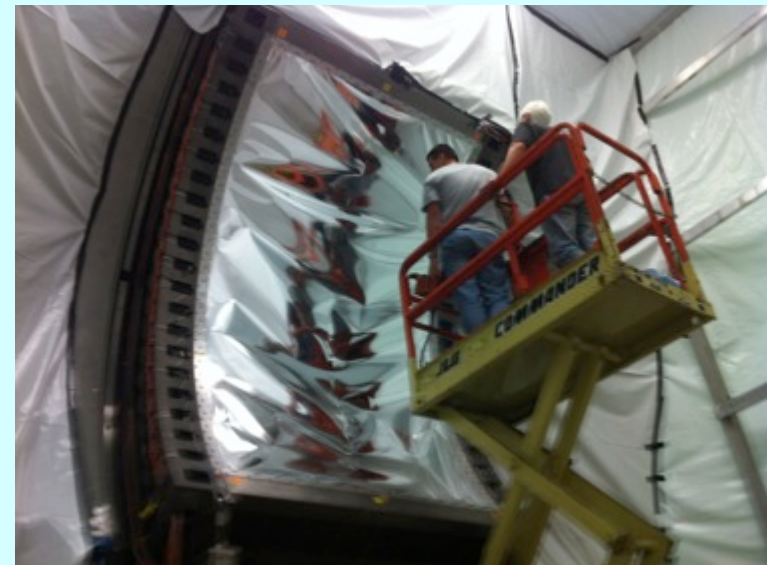
DC East & West Repairs/Upgrade

DC West repairs complete

May need to repair broken wires later

(need to take down station 1 scaffolding
to Move West Carriage)

Finishing DC East

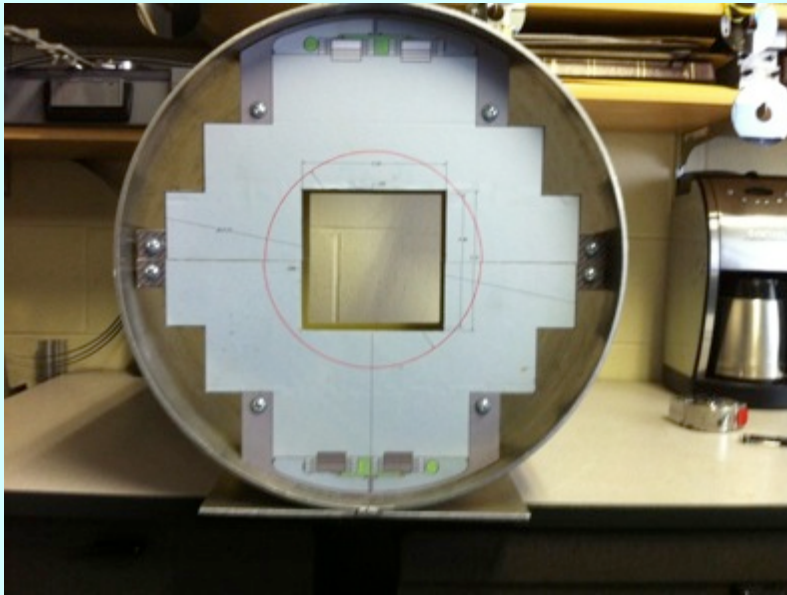
MPC-Ex mockup to be used for cable and utilities routing plans

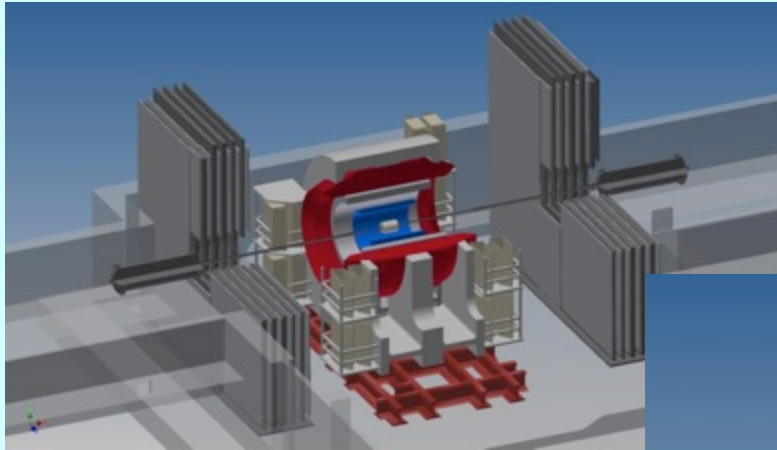
Added reinforcements to support columns to prevent buckling

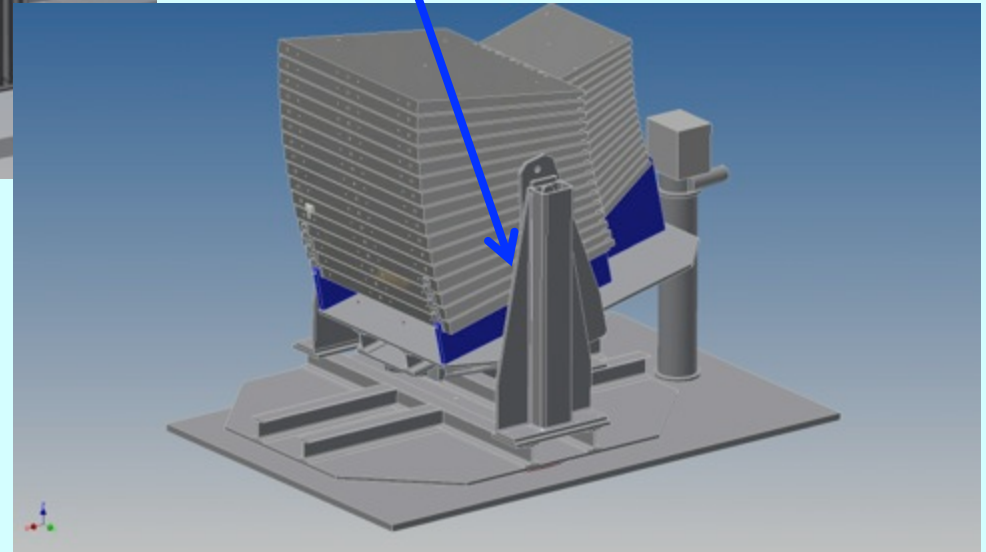
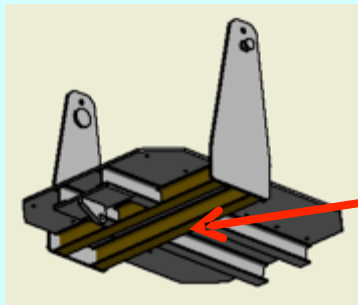
I-beams added to base to stiffen

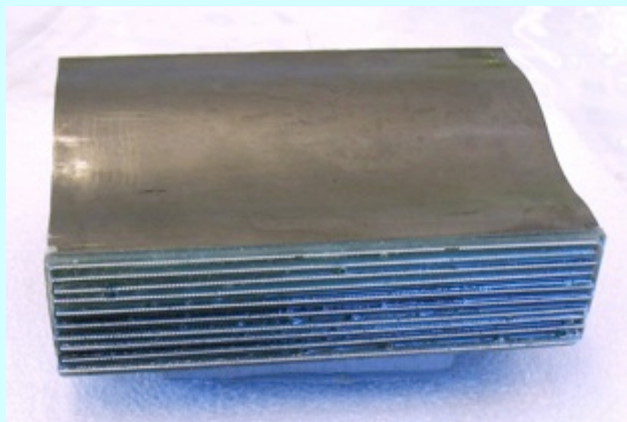
Prototype accordion plates with fibers produced as part of SBIR. EMCal for test beam will be flat tapered plates

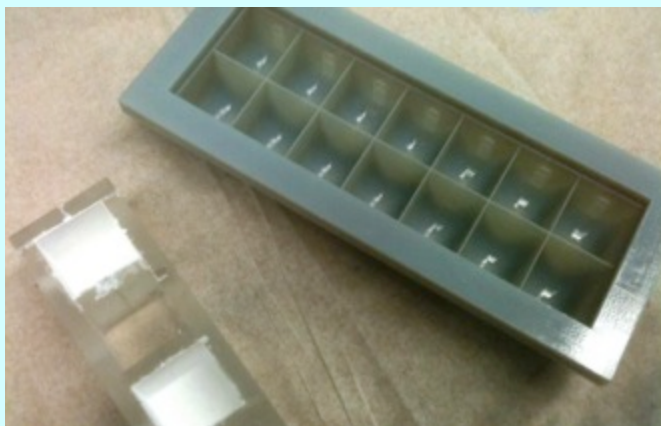
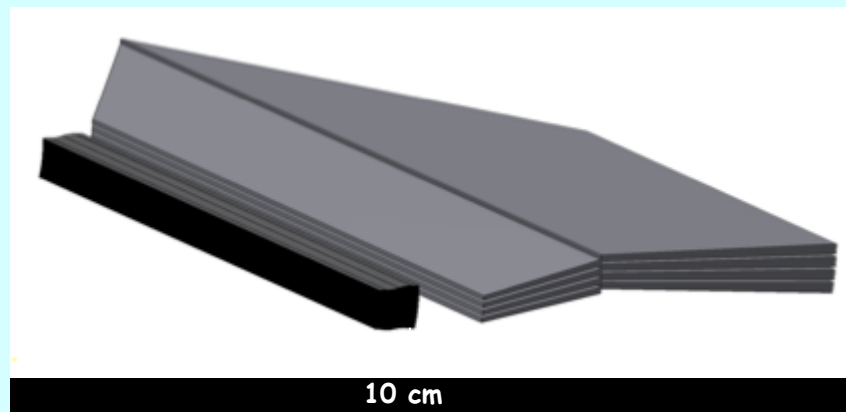
Prototype "Egg Carton" light collection

Proto-type EMCal in front of proto-type HCal

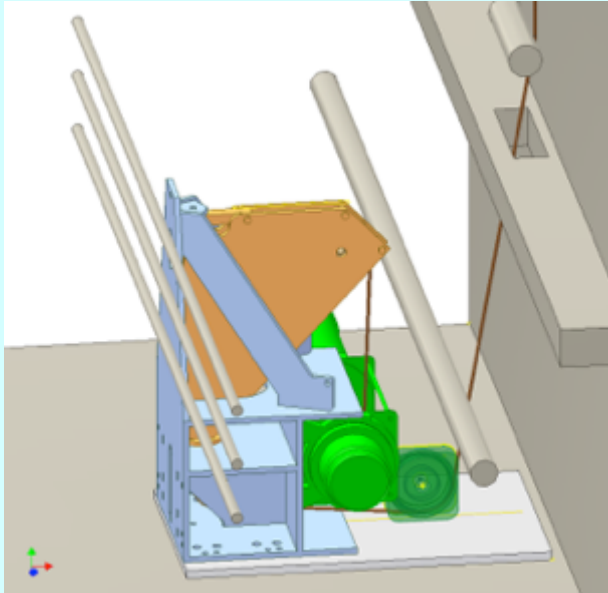
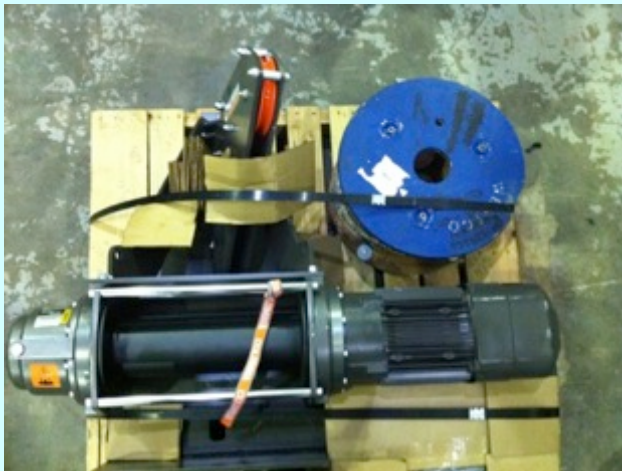
West Carriage moved to run position creating access. Need baseplate and anchors.

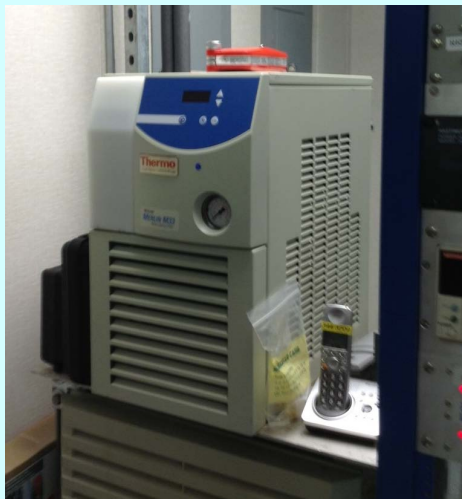
Merlin Chiller

➤ Chiller supplied about ½ the flow as in the past.

- Pressure on chiller says ~70-80psi
- Install gauge on supply line and measure actual output pressure.
- Replace chiller with spare if needed.
- Send old chiller out for maintenance or replace.

New Chiller on Order.

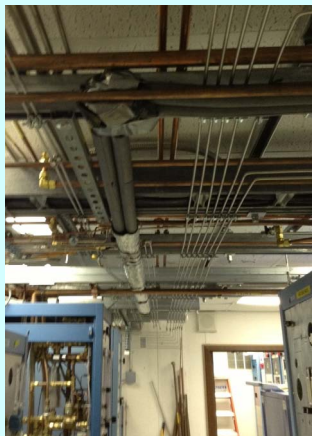
Re-Insulate Glycol lines

❖ Remove old polyethylene insulation and wrap and replace with foam rubber insulation.

- Temp of fluid is affected too much by temp change in the gas house.
- Lines are condensing and dripping because of gaps in insulation.

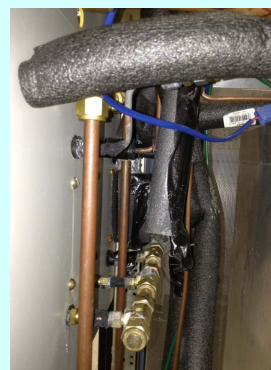
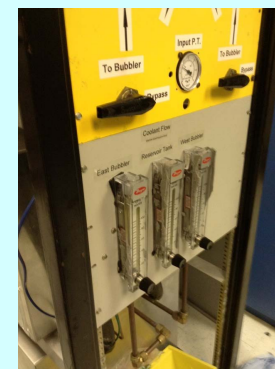
Locate and fix Glycol Leak.

- Replace all three flow meters (compatible with Propylene Glycol)
 - switch to Visi-Float (VFA) for better compatibility
- Redo connections (replace fittings) behind flow meters
 - Re-insulate all cold lines with foam rubber insulation.

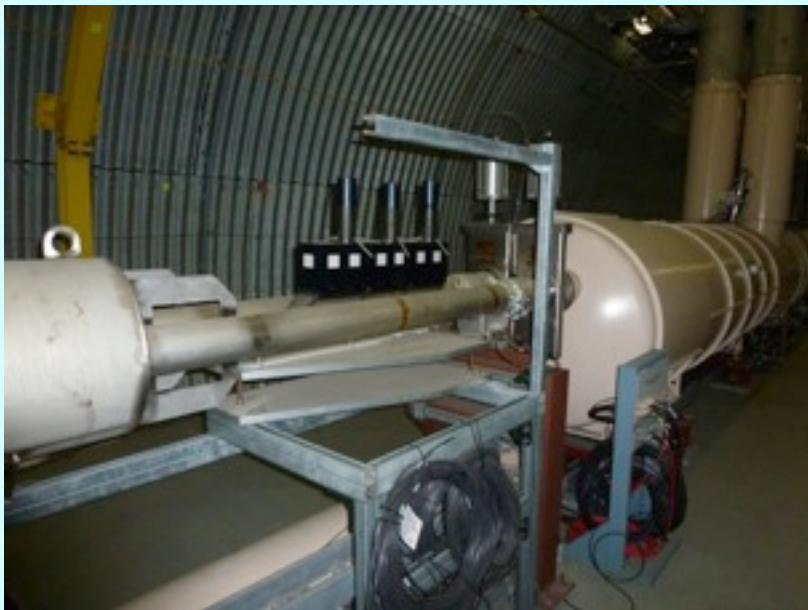
- ZDC Remove, Test, Recalibrate

Access on South side enhanced by shielding removal for DX magnet repositioning effort. Overhead cranes can now be used with existing fixture to remove ZDC modules
